WHEN THE CHICKENS COME HOME TO ROOST, HECAT'S COOLANT PULSATOR SAVES THE DAY

By Stu Oltman, Senior Technical Editor

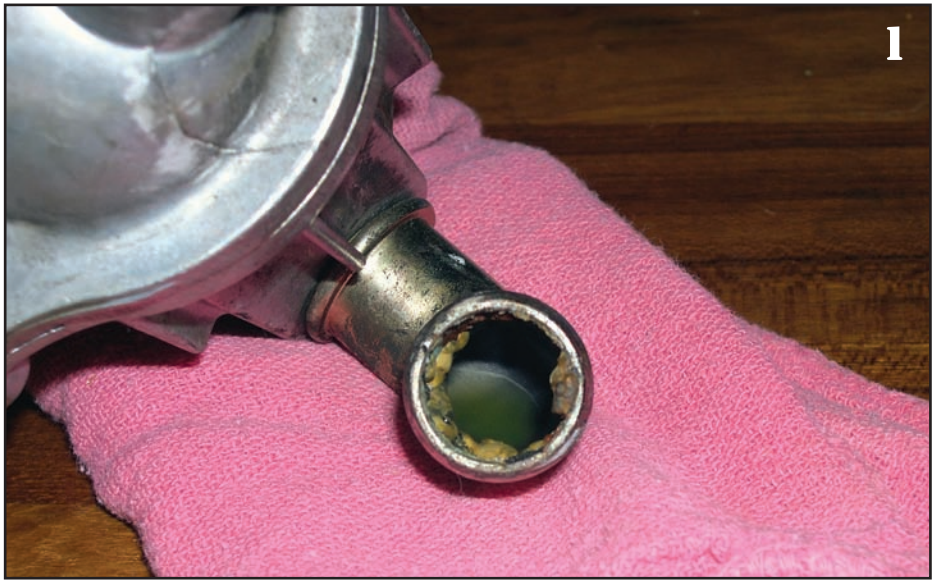
1

Contaminated pump housing.

be okay. Still, having done the requisite surgery just to access the thermostat, a new one was installed on principle. But before reassembling the housing containing the thermostat and coolant pump, it made sense to remove the severe clogging evident in the cylinder head bypass hose inlet (see Photo 1). This material was hard and crusty and could only be removed by reaming with a rotary brush. We estimated it was causing at least a 25-percent restriction in that line, and it certainly pointed to the likelihood of similar contamination elsewhere in the cooling system—stuff that a garden hose could never remove.

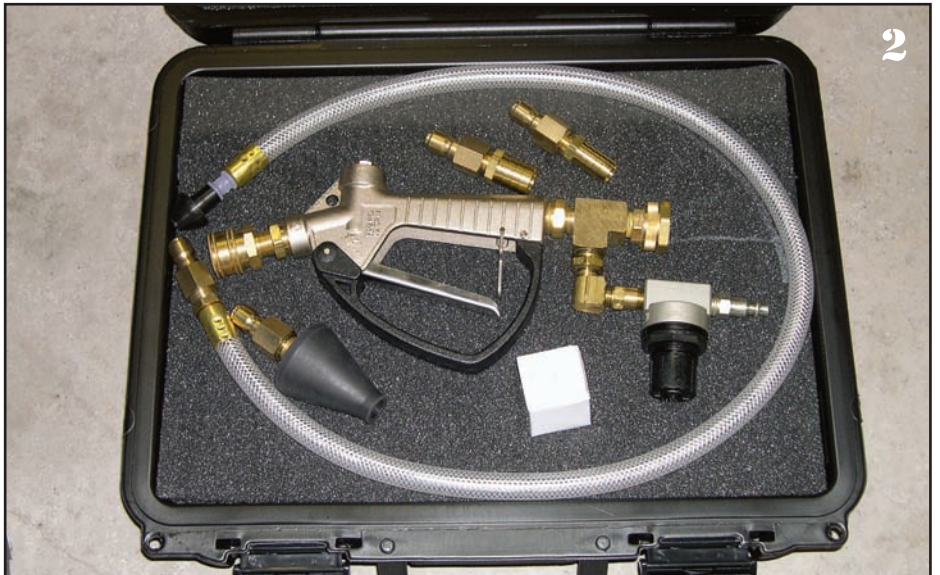
2

Coolant Pulsator.

As we considered the alternatives, I happened to spy a new product release in my copy of *Professional Tool And Equipment News*. Manufactured by HECAT, Inc. of Suwanee, Georgia, it was referred to as The Coolant Pulsator (see Photo 2). The claim for this product was that it had the ability to remove severe cooling system contamination through a pulsating jackhammer effect created using water, shop air, and a pulse valve. I had dealt with this company in the past and was happy with their products, so a call was made to see if we could get a sample of “The Pulsator” for evaluation. It arrived in a few days.

As seen in the photo, the product consists of a handle/trigger assembly with attached air pressure regulator, a large rubber cone for sealing off hoses and metal passageways, a hose with small cone for small openings, and two hose barbs for direct connection to radiator or heater hoses. What’s not seen in the photo is the contents of that small white box. It contains a backflow preventing device for attachment to the hose connection on the building. This is necessary, because the air pressure fed into the handle when the trigger isn’t squeezed could actually empty the contents of the garden hose right back into the building’s water mains. Hopeful but skeptical, we detached all hoses connecting the various cooling system components and prepared for the cleaning attempt (see Photo 3).

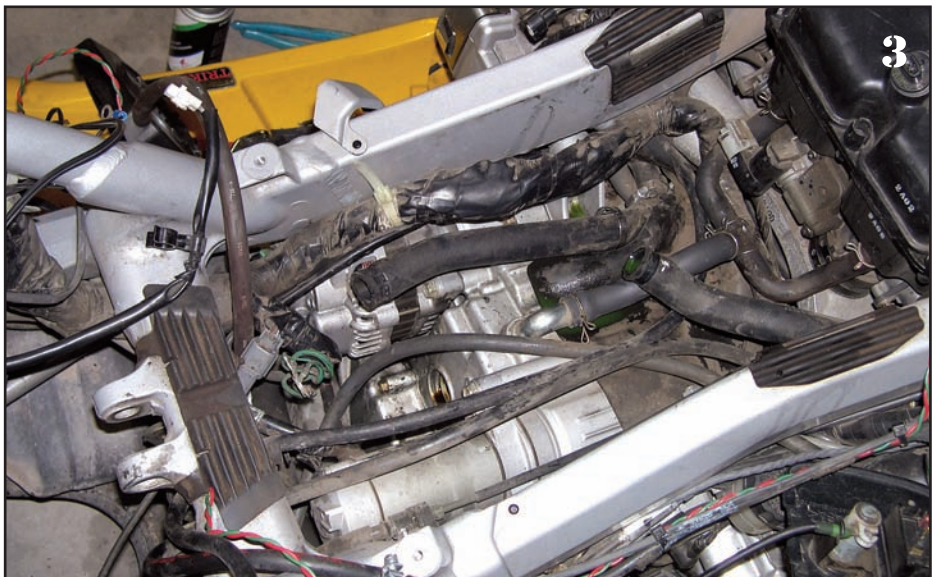
3

All hoses disconnected, ready to attach pulsator.

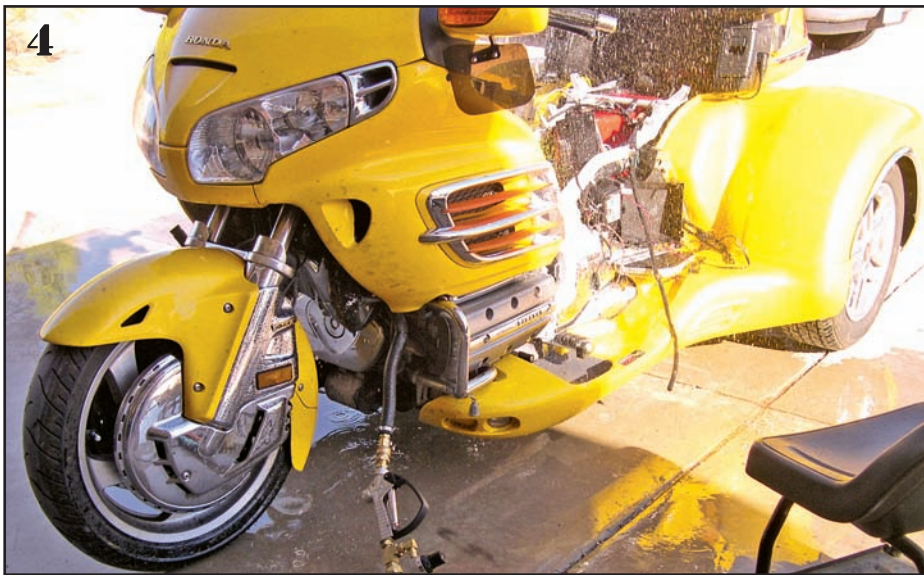
Flushing the left head.

of normal coolant flow, then repeat the procedure in the normal flow direction. Using a hose barb and hose clamp, we first connected the tool to a large hose at the front of the trike that was connected to the left cylinder head (see Photos 4 and 5). What happened next was astounding. We squeezed the trigger and applied its lock. The handle and hose began jumping around as water pulsed from every outlet of the left head (see Photo 6). It can also be seen spraying from the bike’s service drain hole up front. I went to the rear of the head and found I couldn’t hold my hand anywhere near the coolant outlets, because the high-pressure pulse blasted it away.

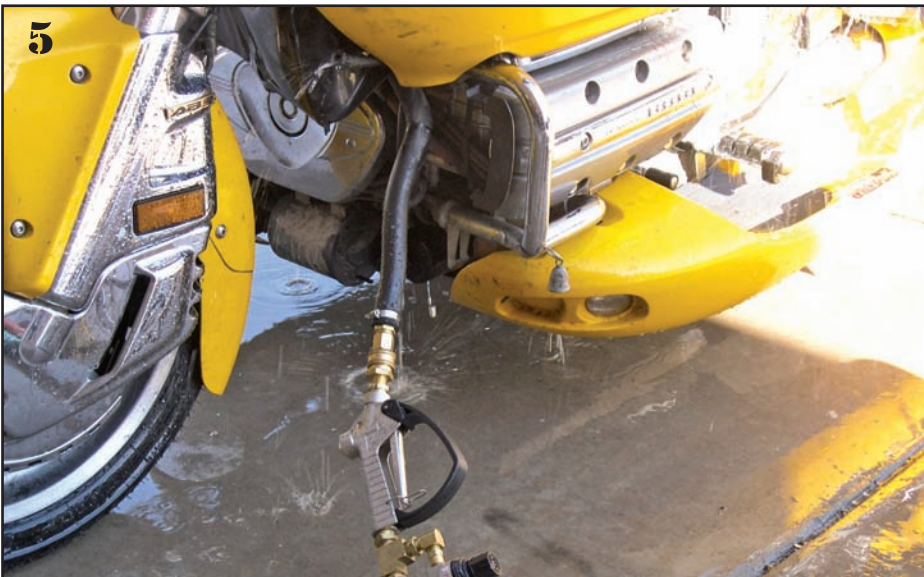
Hose barb connects device What happened next was astounding...

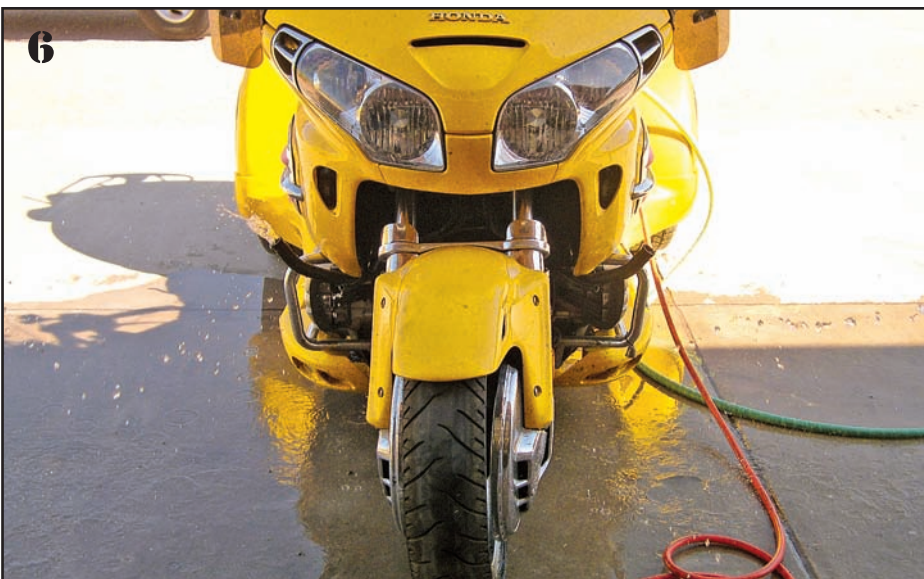
Pressure applied at cylinder head rear blasts through the front hoses.

After flushing both radiators, we noticed a significant flow improvement and proceeded to the cylinder heads. After wedging the small cone in the bypass outlet at the rear of the left head, I squeezed the trigger and...Whoa, Nellie! I could barely hang onto the small hose as it blasted its 75psi pulse through the head. For perhaps 20 seconds, only clear water shot out of the large hose up front. Then, a greenish-gray substance began oozing out onto the garage apron and foaming as it floated away. I have no idea what that stuff was, but I’m sure it didn’t belong in the cooling system. It was interesting (to me) that it took a bit of time before whatever this crud was broke loose from its moorings and exited the cylinder head. No doubt about it; The Pulsator was accomplishing something I hadn’t a prayer of doing otherwise. We followed the rest of our game plan.
